Name Of Dam: Lake of the Woods

Location: Orange County, State of Virginia

Inventory Number: VA 13701

PHASE I INSPECTION REPORT NATIONAL DAM SAFETY PROGRAM

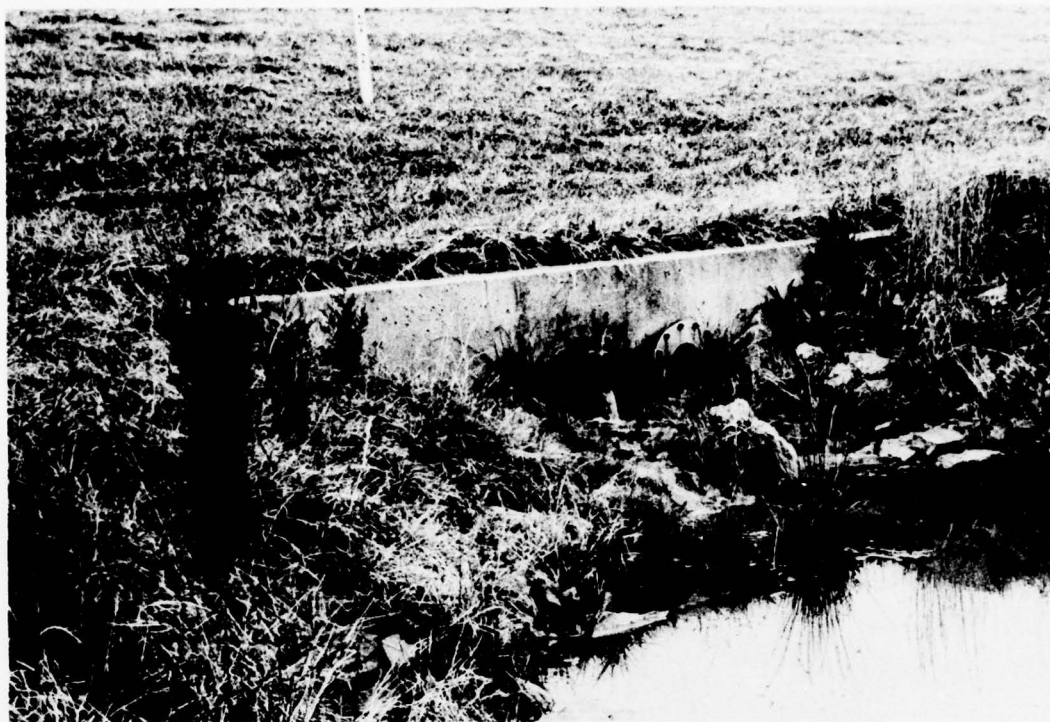
3.1.3 Appurtenant Structures: The intake portion of the reservoir drain is submerged. The plug valve and outlet pipe appear to be in good condition. There was no flow from the outlet pipe (Photo 1).

PHOTO 1. Head Wall Containing Filter Drainpipe (Left Side of Photo) and Reservoir Drainpipe (Right Side of Photo)

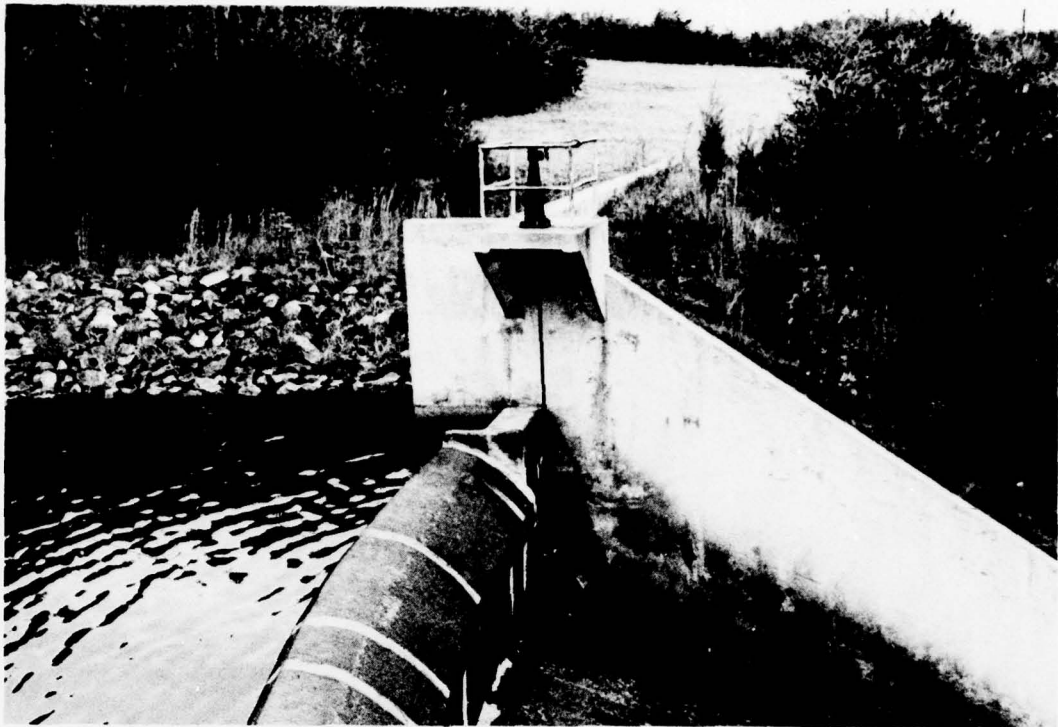
The concrete spillway functions adequately in spite of minor deterioration which includes epoxy patching in nine areas with clear leakage at two locations. There are small popouts of aggregate on the crest of the weir and in the spillway. Minor settlement (less than 2 feet) of the backfill adjacent to the left (north) wall should be corrected by the addition of compacted soil and seeding. The clear seepage and eroded area at the end of the right wall beside the stilling basin should be covered with rock to prevent further erosion. There is some clear leakage in the patched stem of the weir adjacent to the slide gate. Photos 2-6 show the deterioration of the spillway.

PHOTO 3. Riprapped Approach Channel, Concrete Overflow Weir, Lift Pedestal and Slide Gate

It is recommended that the finger drain outlets at the toe be located and opened into the drainage channel along the toe of the dam. The epoxy patches in the spillway that are no longer adhering to the concrete should be repaired, especially around the sluice gate. Rock should be placed over the seepage and erosion area at the end of the right spillway wall beside the stilling basin. The area behind the left spillway wall, where settlement has occurred, should be filled with soil, compacted, and seeded. The following minor maintenance items should be accomplished as part of the yearly maintenance program: fill and seed bare areas on the embankment, remove small trees from the drainage ditch at the toe, replace dislodged or missing riprap, remove

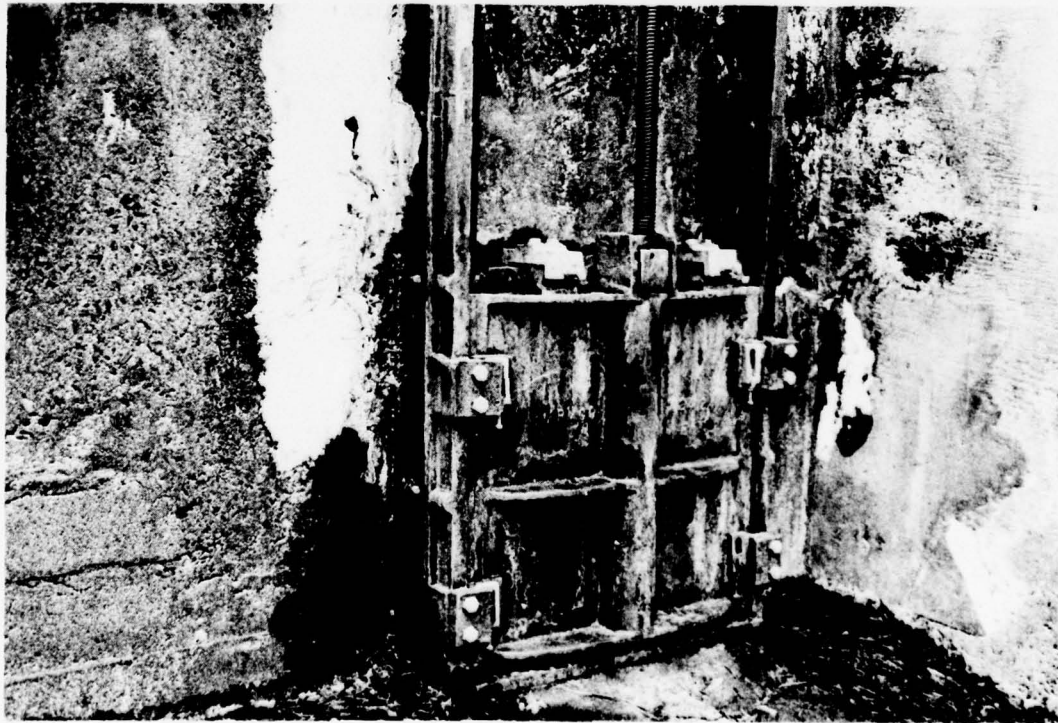
PHOTO 4. Slide Gate on Downstream Face of Weir.

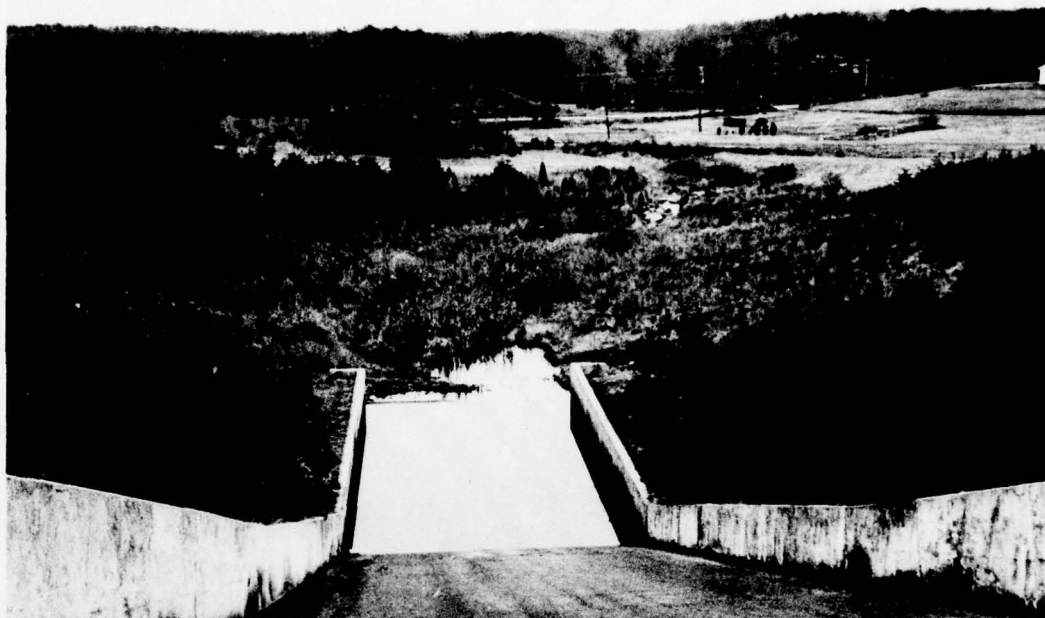
PHOTO 5. Spillway, Stilling Pool and Downstream Channel

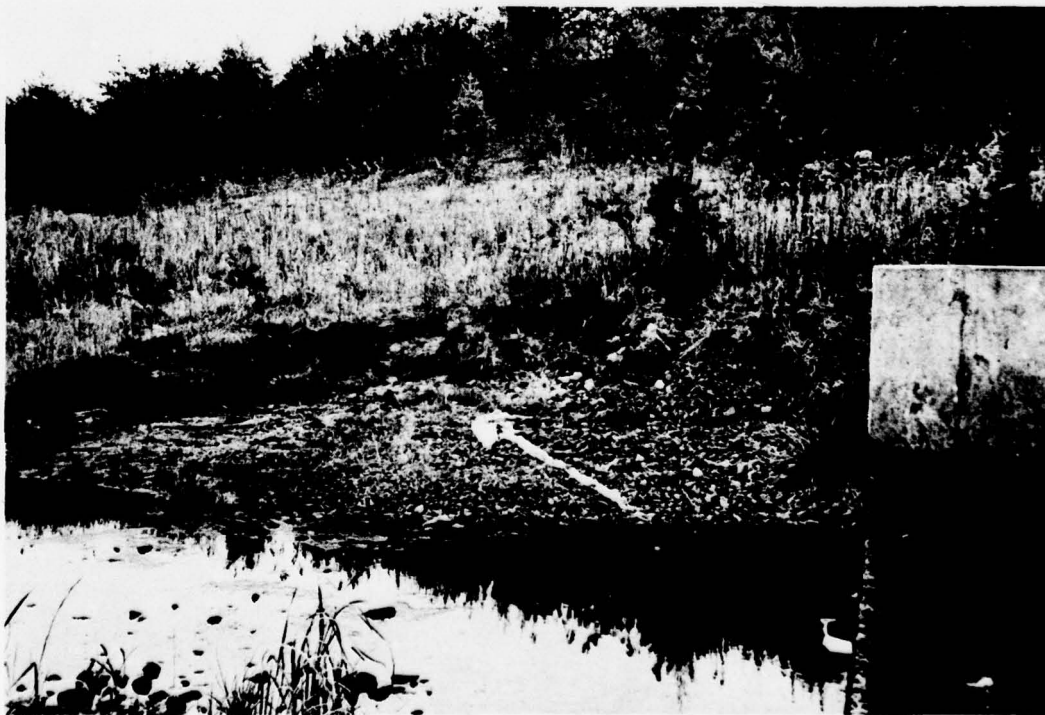
3.1.5 Downstream Channel: The outlet channels for the reservoir drain and spillway are in satisfactory condition. There is some minor erosion on the slopes where clear seepage is present downstream from the spillway.

PHOTO 6. Large, Wet Area on Left Abutment to Right of Spillway
